Replacement Standards For Temple Facilities

Temple Department

September 30, 2004

Replacement Standards

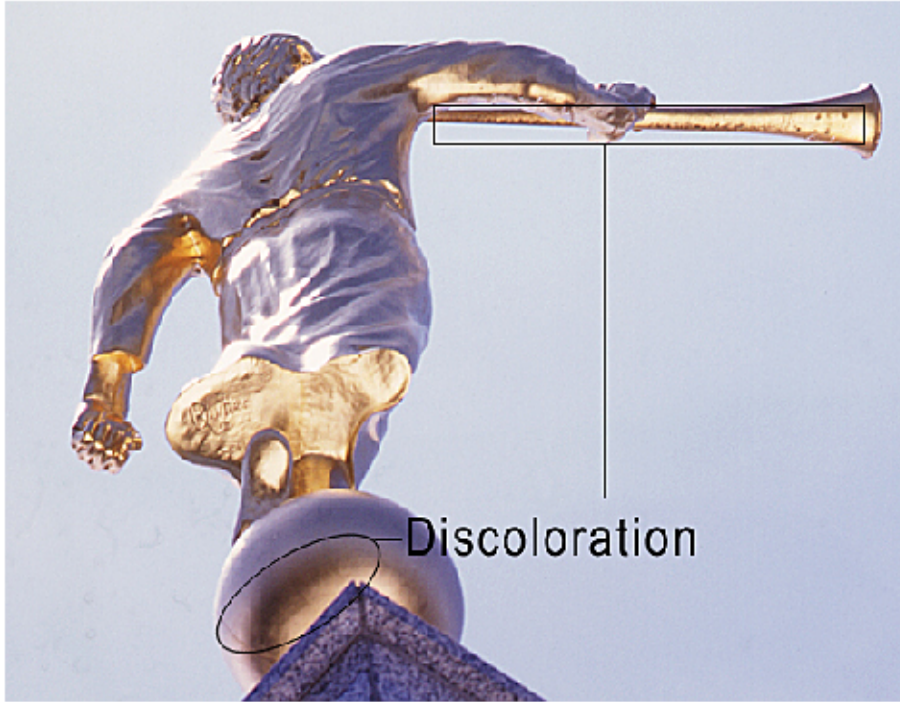
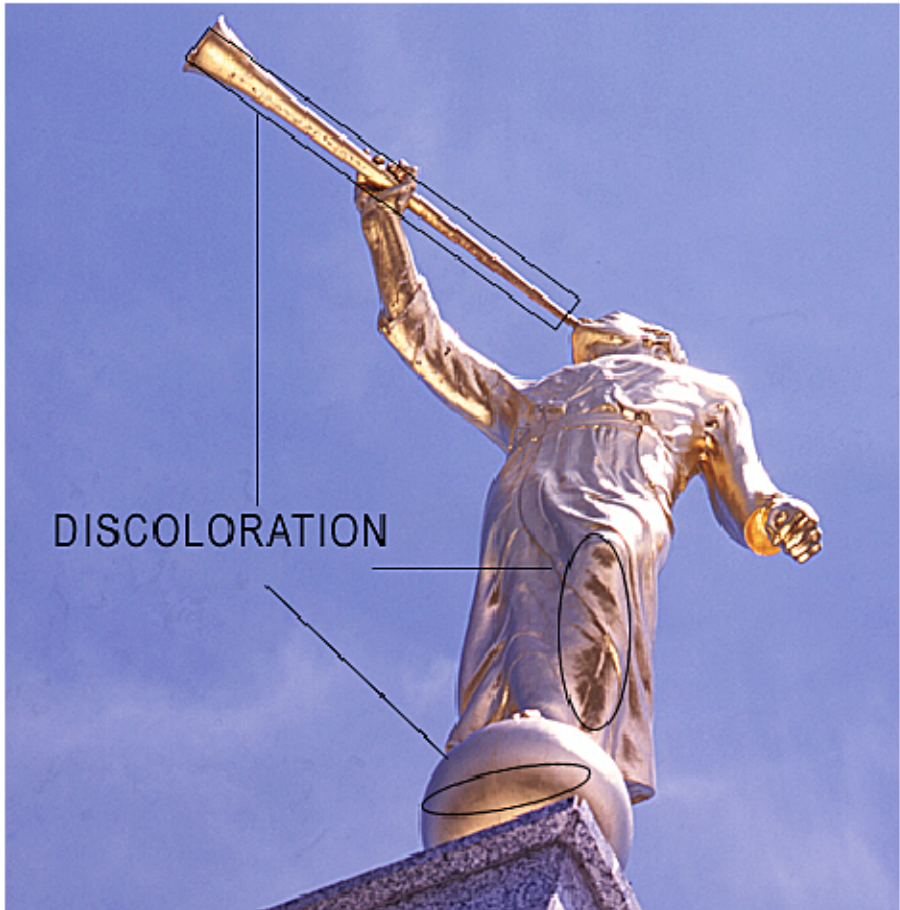
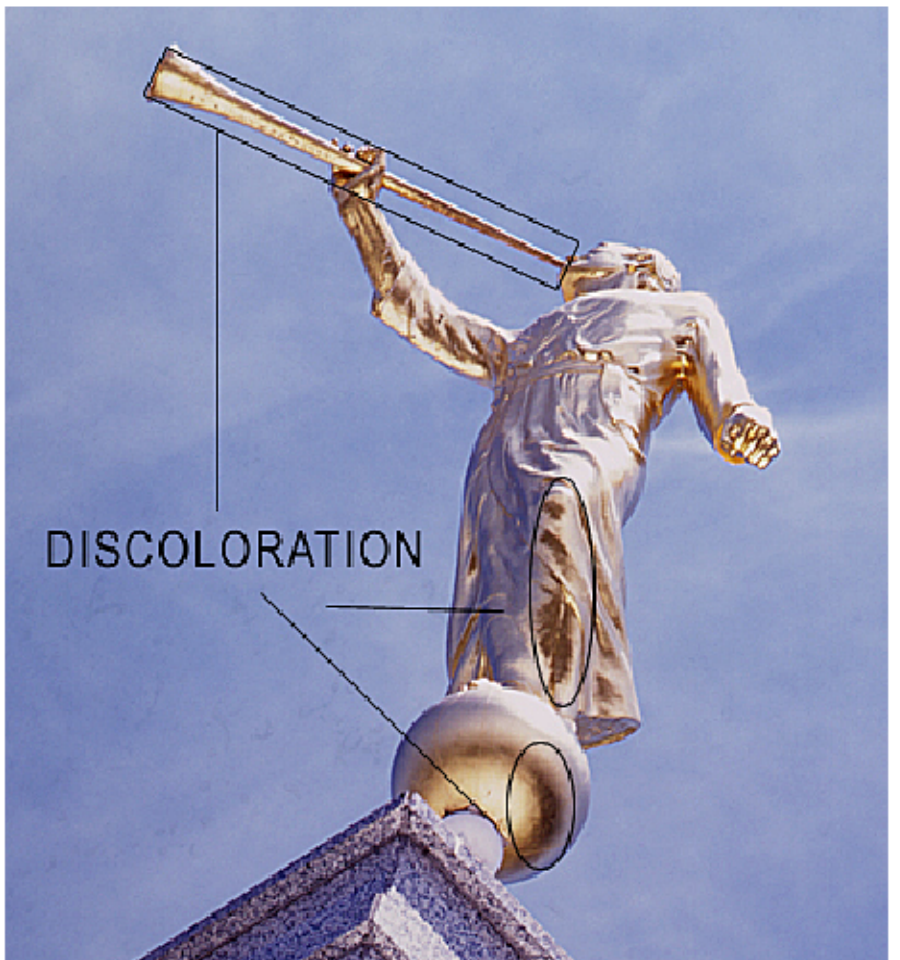
See the attached three pictures for a level 3 statue of the Angel Moroni.

3. Good. Fiberglass is showing defects, but is generally within acceptable limits. (It should be possible, with proper and timely repairs and preventive maintenance, to extend the life of the gold leafing in this condition for many years.)	The fiberglass statue is showing slight yellowing or dulling, discoloration, and cracking. Regular spot cleaning has kept the fiberglass attractive. There may be some cracked but no broken or missing fiberglass pieces. Repairs and refinishes have been made to correct fading, cracked, and chipped fiberglass. 75% of the fiberglass in the area being considered is still in good condition.	Propose replacement of oxen statues. Do not propose replacement of the Angel Moroni statue. Evaluate the statue annually until replacement is required. Evaluate the costs of scaffolding and an average cost of US \$ 14,000 for the statue.
